## REPORT: Erosion report update for the Bell River - Duke of Wellington Bridge and Pioneer Park

**DIVISION:** Community, Culture and Places  
**REPORT DATE:** 13 February 2023  
**TRIM REFERENCE:** ID23/235

#### Priority Site Summary – Site 2 – Pioneer Park, Wellington, NSW

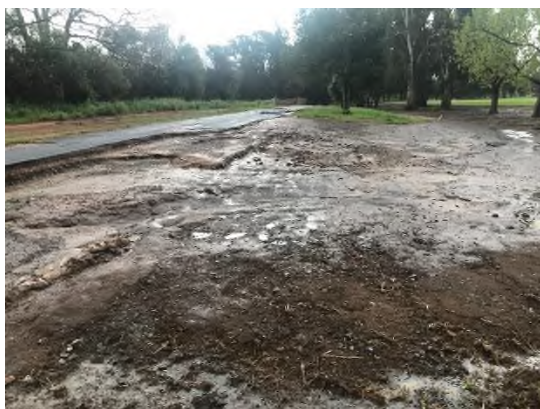
Photograph 1. Internal road – west side Pioneer Park looking north.

As shown in photographs 1 – 3 the internal road and pathway at Pioneer Park has been effectively washed away. \$650,000 has been allocated to restore access to the Pioneer Park and reconstruct the internal road and path system. Discussions have been held internally with Infrastructure Strategy and Design to look at options as well as external discussions with the user groups of Pioneer Park. The priority is to re-establish access at the eastern entry of Pioneer Park through to the amenity block. This is proposed to be a 2-way access and car parking area. The construction method of both the internal road and path system to reconnect the new bridge back through to Showground Road will help reduce future risk of damage.

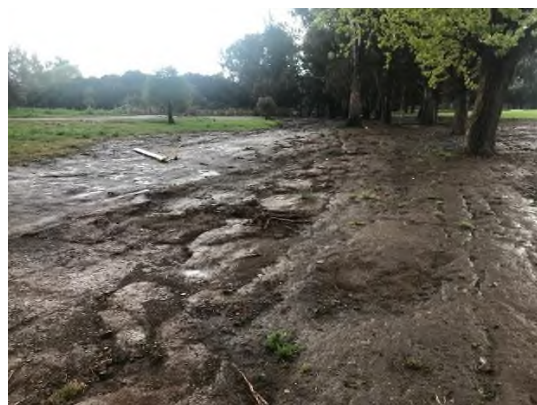
Photograph 2. Carpark – west side Pioneer Park looking north. Many of the large river red gums have significant soil loss around their root zone.

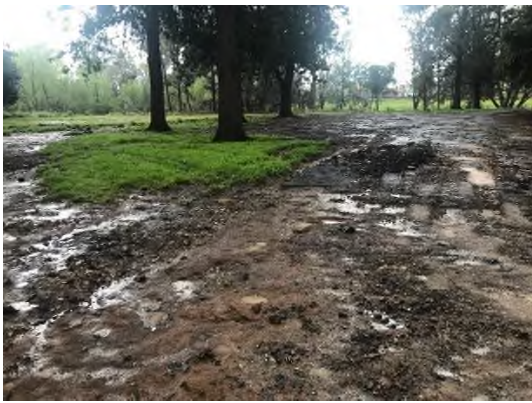
Photograph 3. Internal road north, looking east.

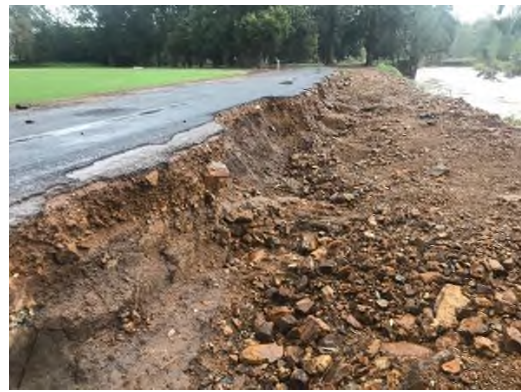
Photograph 4. Internal road and previous location of pathway, which was located at the same grade of the road.

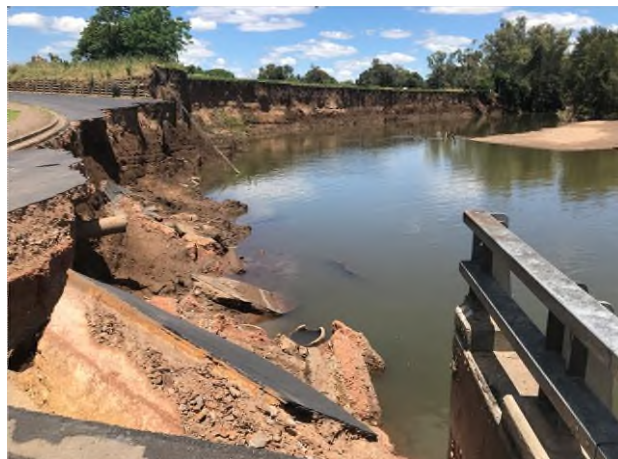
Photograph 5. Resultant damage to the reserve and approach to the southern end of the Duke of Wellington Bridge

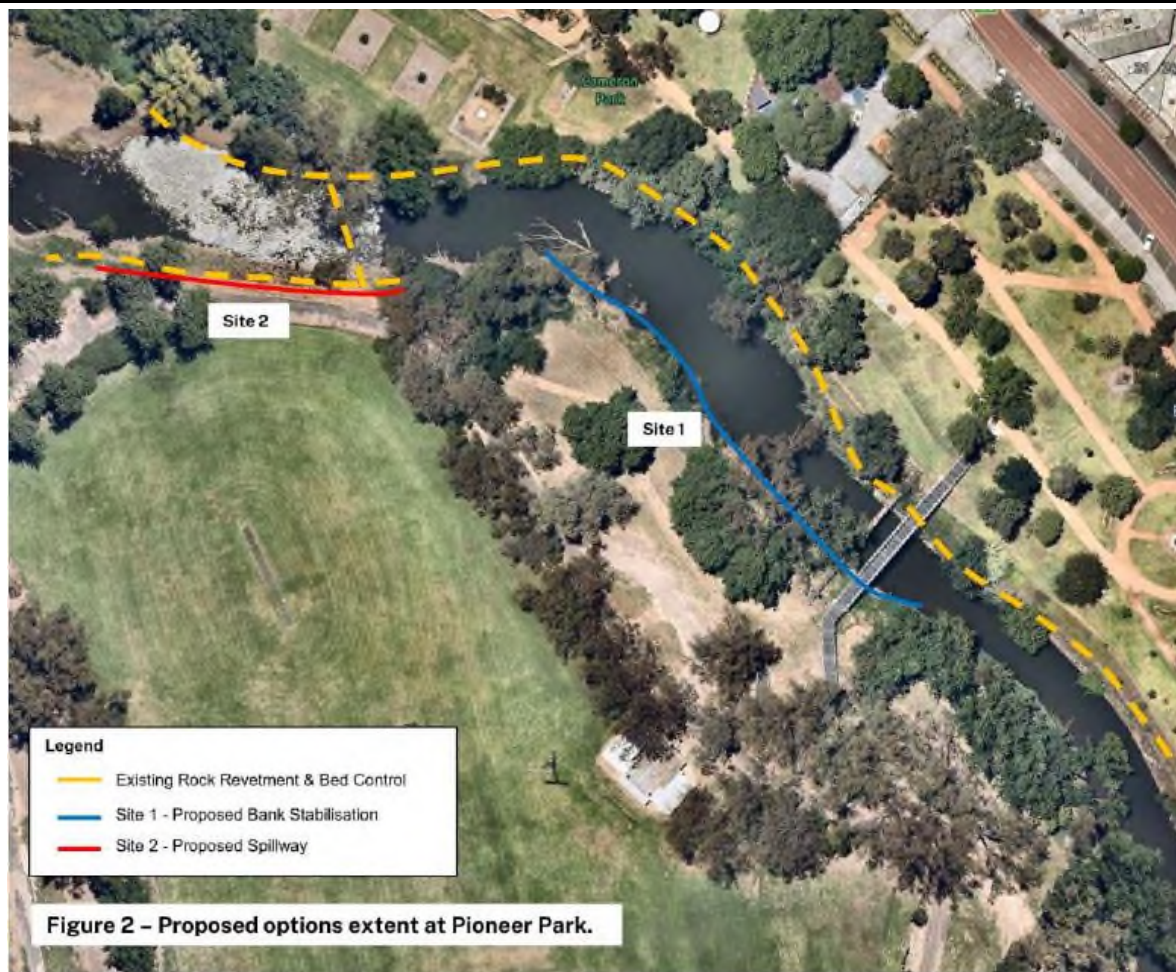
Figure 1. Pioneer Park showing extent of existing bank stabilisation works (yellow) and proposed extent of works at site 1 (blue) and site 2 (red).

1. Bank stabilisation – rock revetment on left bank – approximately 125 metres OR
2. Bulk earthworks (where required) and revegetation to increase hydraulic roughness and resilience of the left bank (recommended).

1. Rock spillway with vegetated verge tying into existing rock revetment.

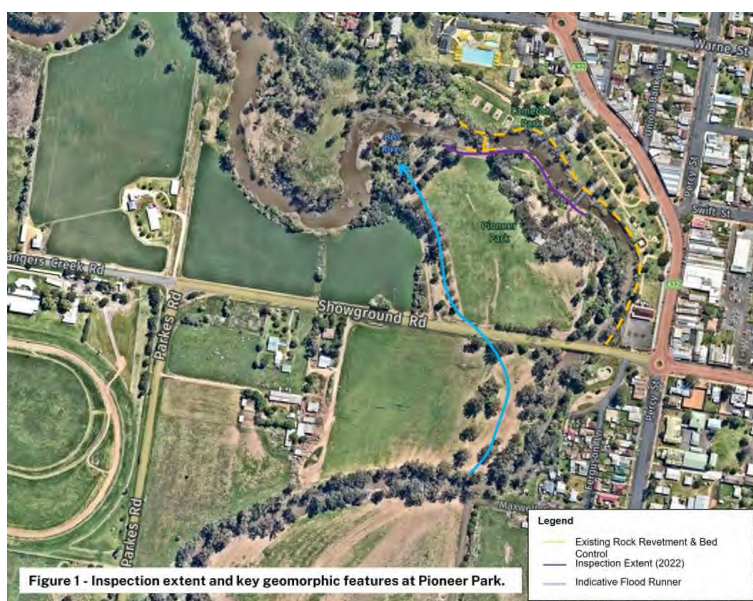
Figure 1 - Inspection extent and key geomorphic features at Pioneer Park.

The most upstream bed control is located to the north of Pioneer Park with rock revetment present on the full extent of the right bank to Showground Road and immediately downstream of the bed control on both banks. Figure 1 provides an overview of the inspection extent and key features at the site.

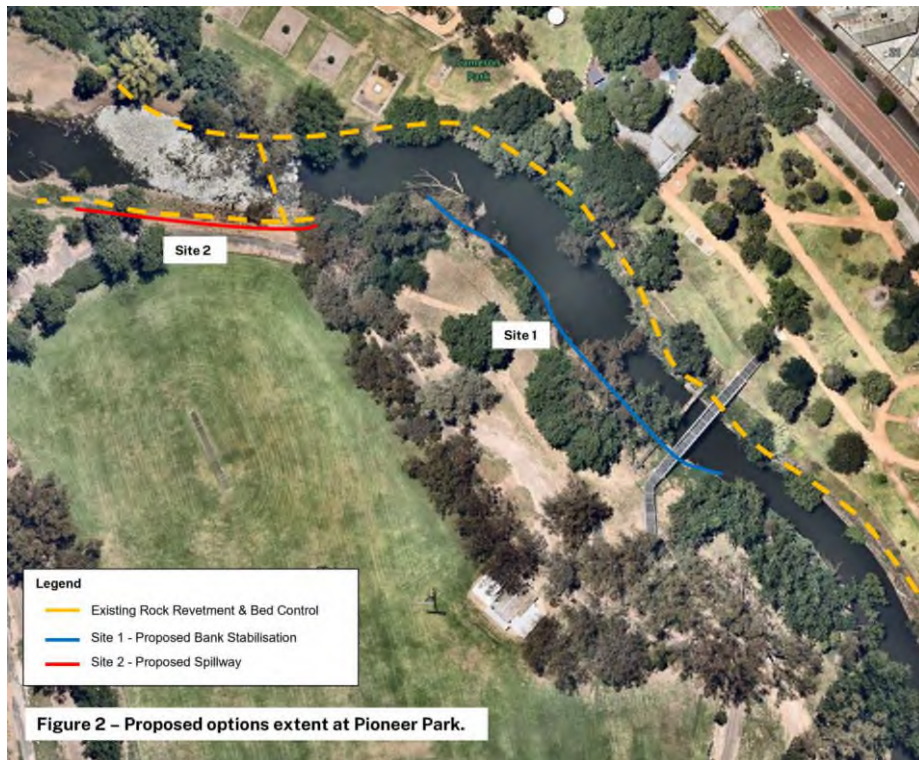
Figure 2 below provides an overview of the extent of works with a preliminary sketch attached.

1. Bank Stabilisation – rock revetment left bank approximately 125m OR
2. Bulk earthworks (where required) and revegetation to increase hydraulic roughness and resilience of the left bank in the event of future floods. (recommended)

1. Rock spillway with vegetated verge tying into existing rock revetment

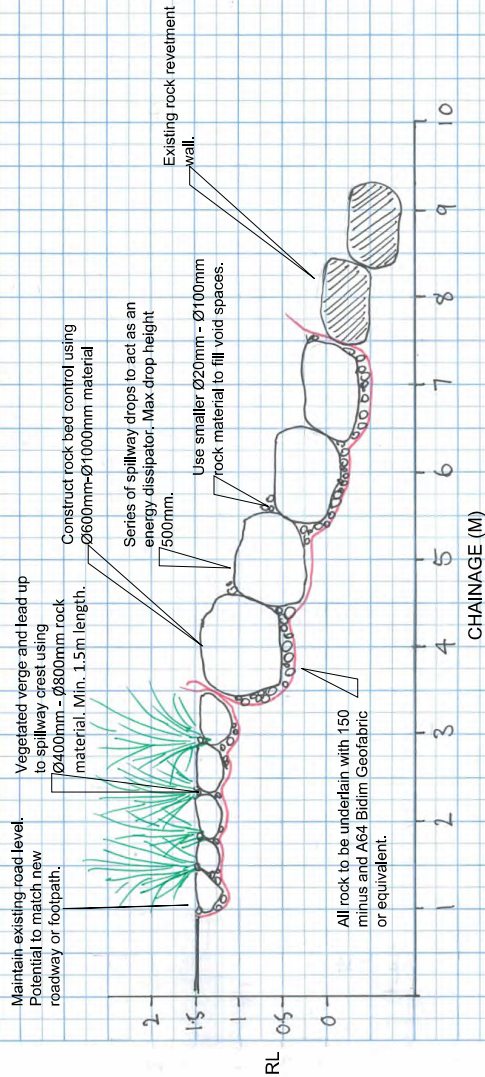
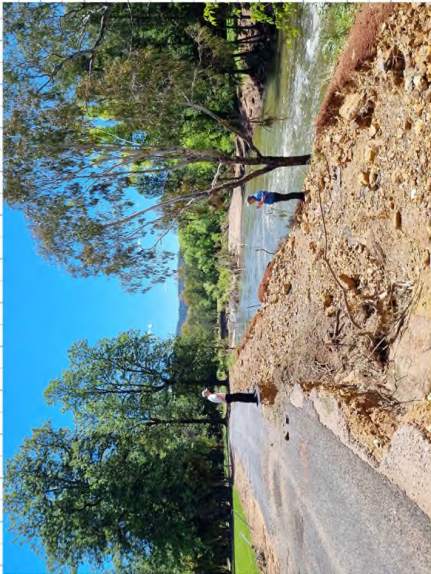
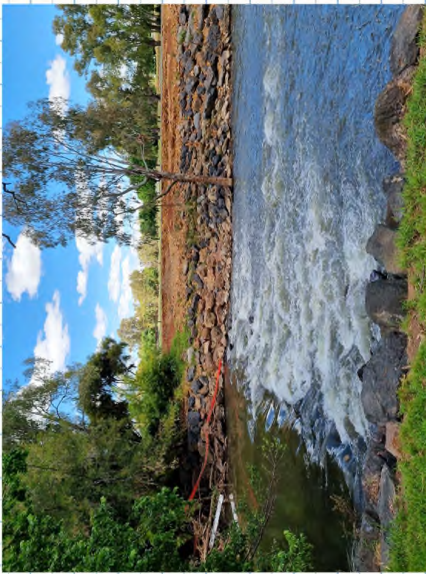
DUBBO REGIONAL COUNCIL - PIONEER PARK - SITE 2  
DESIGN CONCEPT  
Rev 1 - 04-02-2023

- Long-section length may vary.
- Approximate extent of works 45m
- Plantings to include native species that will survive during dry periods and bend over when submerged during inundation so as not to form a flood barrier e.g. Lomandra Longifolia.
- Special attention should be taken at the upstream extent to ensure flows are captured by the structure.

Note: Concept Design only. Actual alignment and placement of rock to be determined onsite.
