## REPORT: Erosion report update for the Bell River - Duke of Wellington Bridge and Pioneer Park

**DIVISION:** Community, Culture and Places  
**REPORT DATE:** 13 February 2023  
**TRIM REFERENCE:** ID23/235

#### Priority Site Summary – Site 2 – Pioneer Park, Wellington, NSW

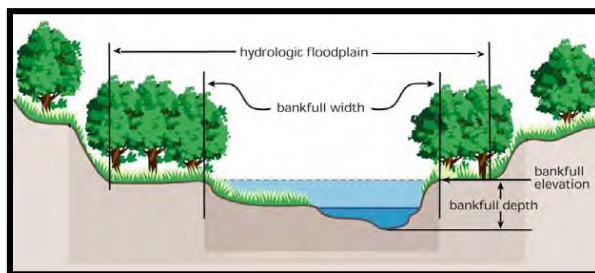
*Figure 1: Schematic illustrating a benched channel form in section.*

Based on visual inspection and basic measurements, SCS propose to undertake bulk earthworks to reinstate stable batters suitable for planting and to construct benches to increase flood capacity where possible. SCS also propose to undertake revegetation with native species to increase hydraulic roughness and resilience of the left bank in the event of future floods. This would also improve habitat for the Platypus.

SCS have allowed for and propose the following scope of works:
