# Geotechnical Investigation Report

**Client:** Dubbo Regional Council

**Site Address:** “Keswick Estate Stage 7, 8 and 9” Dubbo NSW

**Our Reference:** 44935-GR01\_A

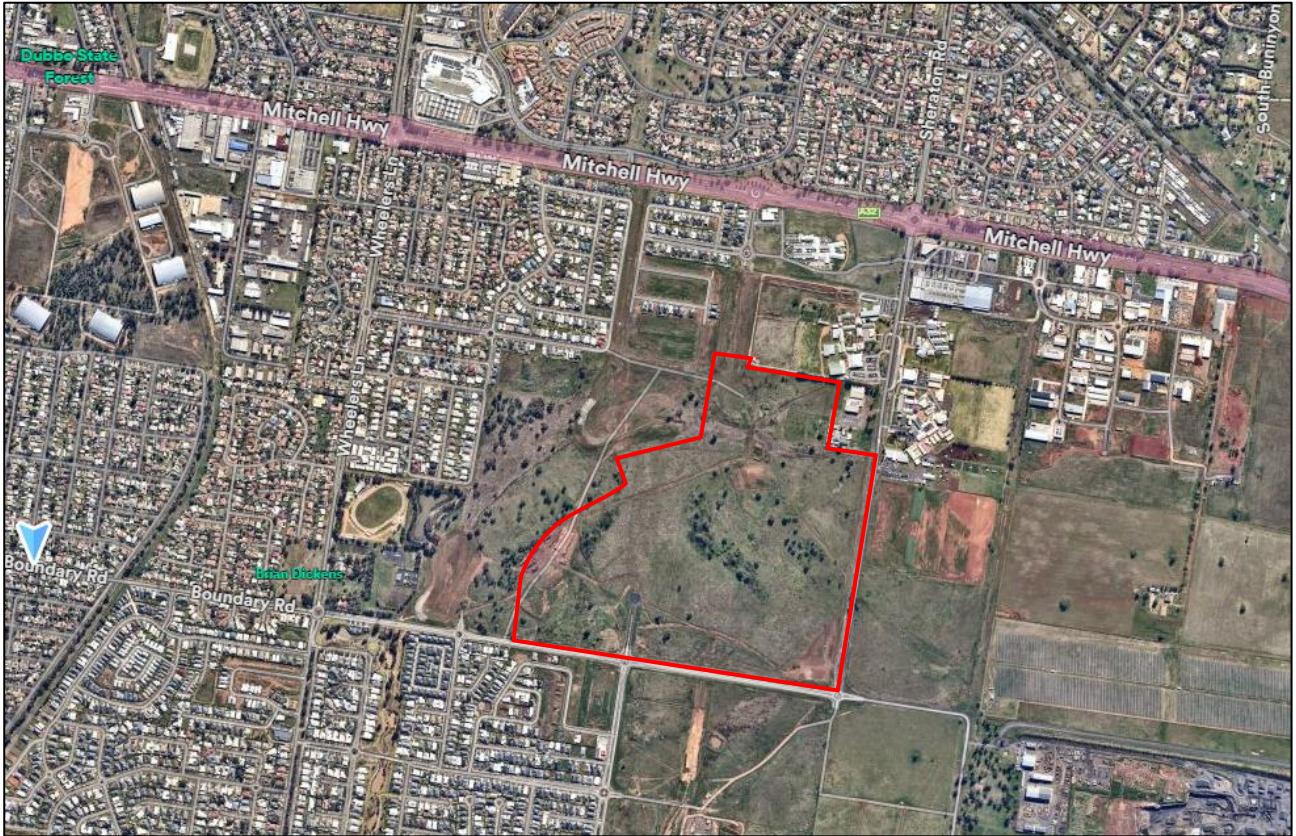
Plate 1 – Area of Investigation – Nearmap 2024

| Plate 1 – Area of Investigation ..... | 5 |

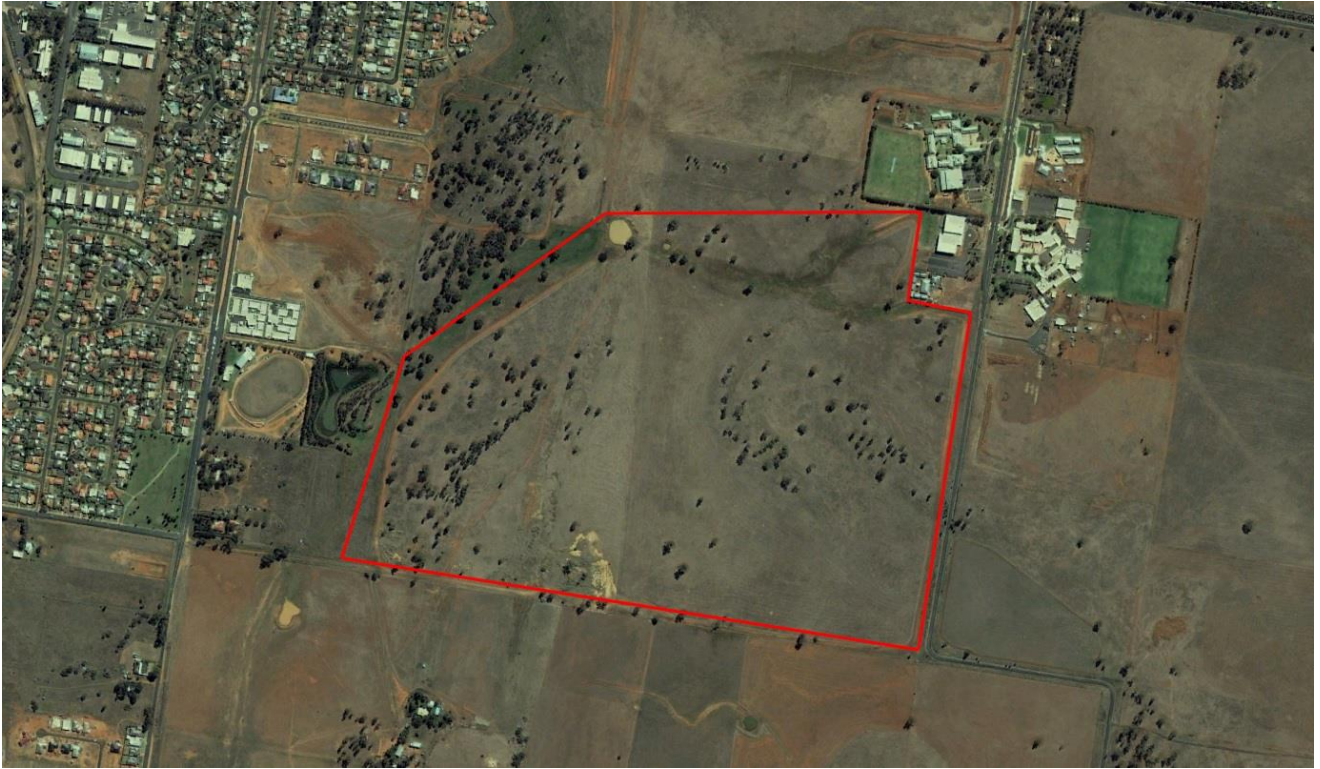
A review of Google Earth imagery indicates the site is in similar condition as to when the image was taken in 2006. The site is therefore assumed to have no recent tree removal. Images exist back to 1985, yet the image is not clear enough to determine site features. See 2006 aerial image below:

Plate 7 – Aerial Image 2006, Courtesy Google Earth.

| Plate 7 – Aerial Image 2006, Courtesy Google Earth..... | 10 |

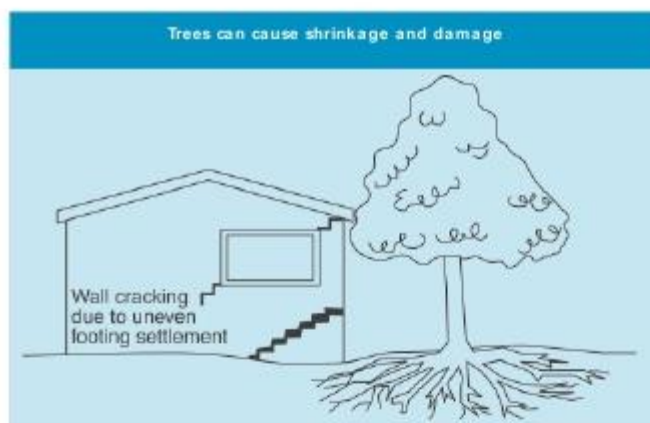
As the moisture absorption process completes its journey to the innermost areas of the building, the internal footings will rise. If the spread of moisture is roughly even, it may be that the symptoms will temporarily disappear, but it is more likely that swelling will be uneven, creating a difference rather than a disappearance in symptoms. In buildings with timber flooring supported by bearers and joists, the isolated piers will rise more easily than the strip footings or piers under walls, creating noticeable doming of flooring.

As the weather pattern changes and the soil begins to dry out, the external footings will be first affected, beginning with the locations where the sun's effect is strongest. This has the effect of lowering the external footings. The doming is accentuated and cracking reduces or disappears where it occurred because of dishing, but other cracks open up. The roof lines may become convex.
